Manhole Inspection Summary

Manhole # S150O1032MH

Inspection ☐ Is Incomplete Rating: **4) Poor**

Location Address: **2601 RUSCOMBE LN**

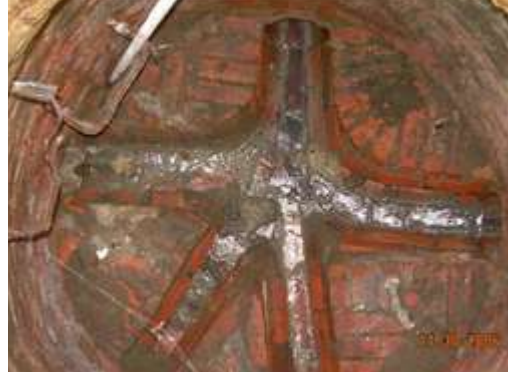
Top View

Corroded steps. Bench debris. Channel debris.

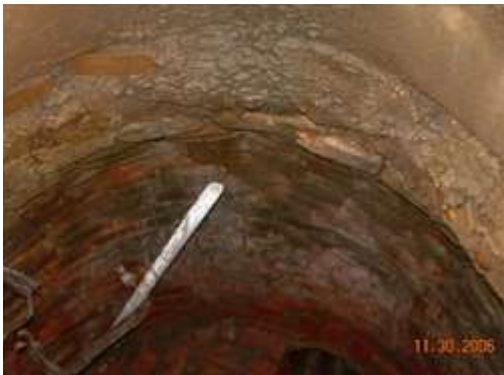
Defect

Frame leaks. Frame offset. Adjustment deterioration and infiltration. Corbel infiltration.

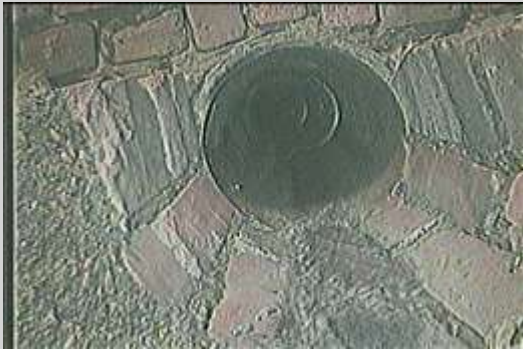
8 in. Circular Gravity Sewer Pipe Out @ 12 O'Clock

Infiltration: **Evidence** Pipe Seal Cond: **Cracked**

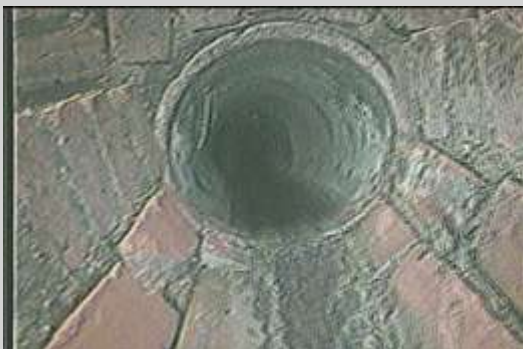
8 in. Circular Gravity Sewer Pipe In @ 3 O'Clock

Channel deterioration.

Infiltration: **Evidence** Pipe Seal Cond: **Cracked**

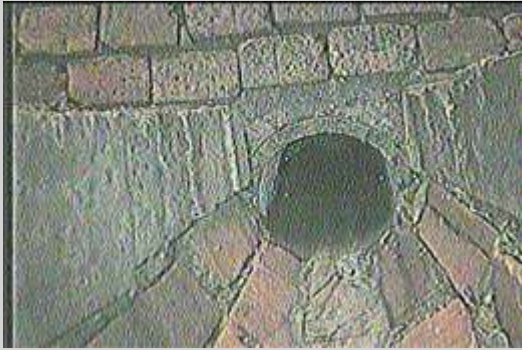
Pipe In @ 6 O'Clock

Barrel deterioration, loose brick and infiltration. Channel deterioration.

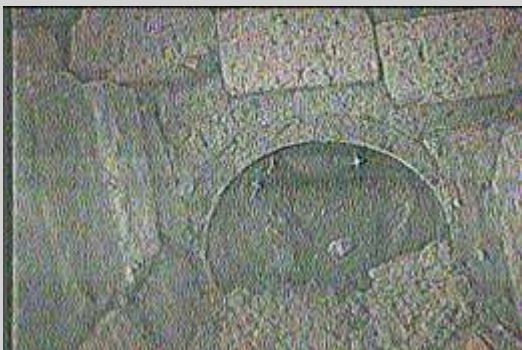
Pipe In @ 7 O'Clock

Deposits: ☐ None ☒ **Mud** ☐ Sludge ☒ **Debris** ☐ Grease

Silt Depth: **2** (in.) Deposits Extent: **Light**
